DEPARTMENT OF TRANSPORTATION

Contract #: 04-0120F4Cty: SF/ALA Rte: 80 PM: 13.2/13.9File #: 69.28**WELDING INSPECTION REPORT****Resident Engineer:**Pursell, Gary**Address:** 333 Burma Road**City:** Oakland, CA 94607**Report No:** WIR-005456**Date Inspected:** 10-Feb-2009**Project Name:** SAS Superstructure**OSM Arrival Time:** 645**Prime Contractor:** American Bridge/Fluor Enterprises, a JV**OSM Departure Time:** 1845**Contractor:** Zhenhua Port Machinery Company, Ltd (ZPMC), Changxing Island **Location:** Shanghai, China**CWI Name:** See Below**CWI Present:** Yes No**Inspected CWI report:** Yes No N/A**Rod Oven in Use:** Yes No N/A**Electrode to specification:** Yes No N/A**Weld Procedures Followed:** Yes No N/A**Qualified Welders:** Yes No N/A**Verified Joint Fit-up:** Yes No N/A**Approved Drawings:** Yes No N/A**Approved WPS:** Yes No N/A**Delayed / Cancelled:** Yes No N/A**Bridge No:** 34-0006**Component:** OBG Fabrication**Summary of Items Observed:**

WELDING INSPECTION REPORT

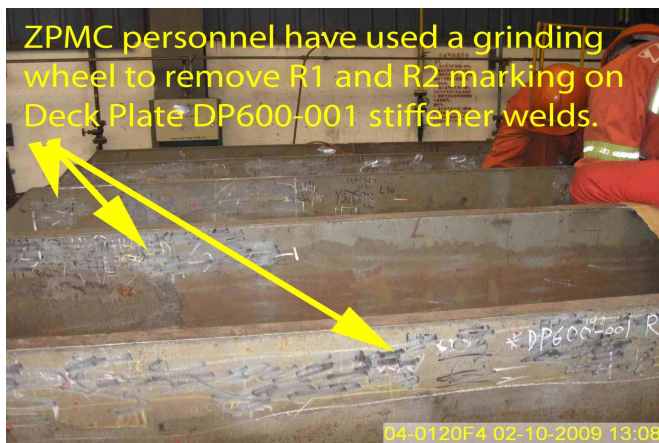
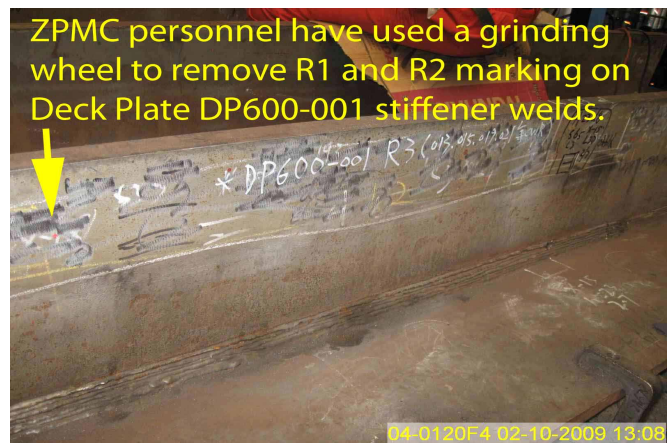
This QA Inspector observed ZPMC is preparing to make repair #3 in several of the stiffener plate welds in deck plate DP600-001 and that ZPMC has ground off the repair #1(R1) and repair #2 (R2) markings. The QA Inspector informed CWI Mr. Gu Xin Zhau that the R1 and R2 marking have been removed and that this information is needed to maintain traceability of the repair cycles. See the photograph below for additional information.
